## NIST Special Publication 996

# On the Fractographic Analysis of Machining Cracks in Ground Ceramics: A Case Study on Silicon Nitride

George D. Quinn  
Lewis K. Ives  
Said Jahanmir

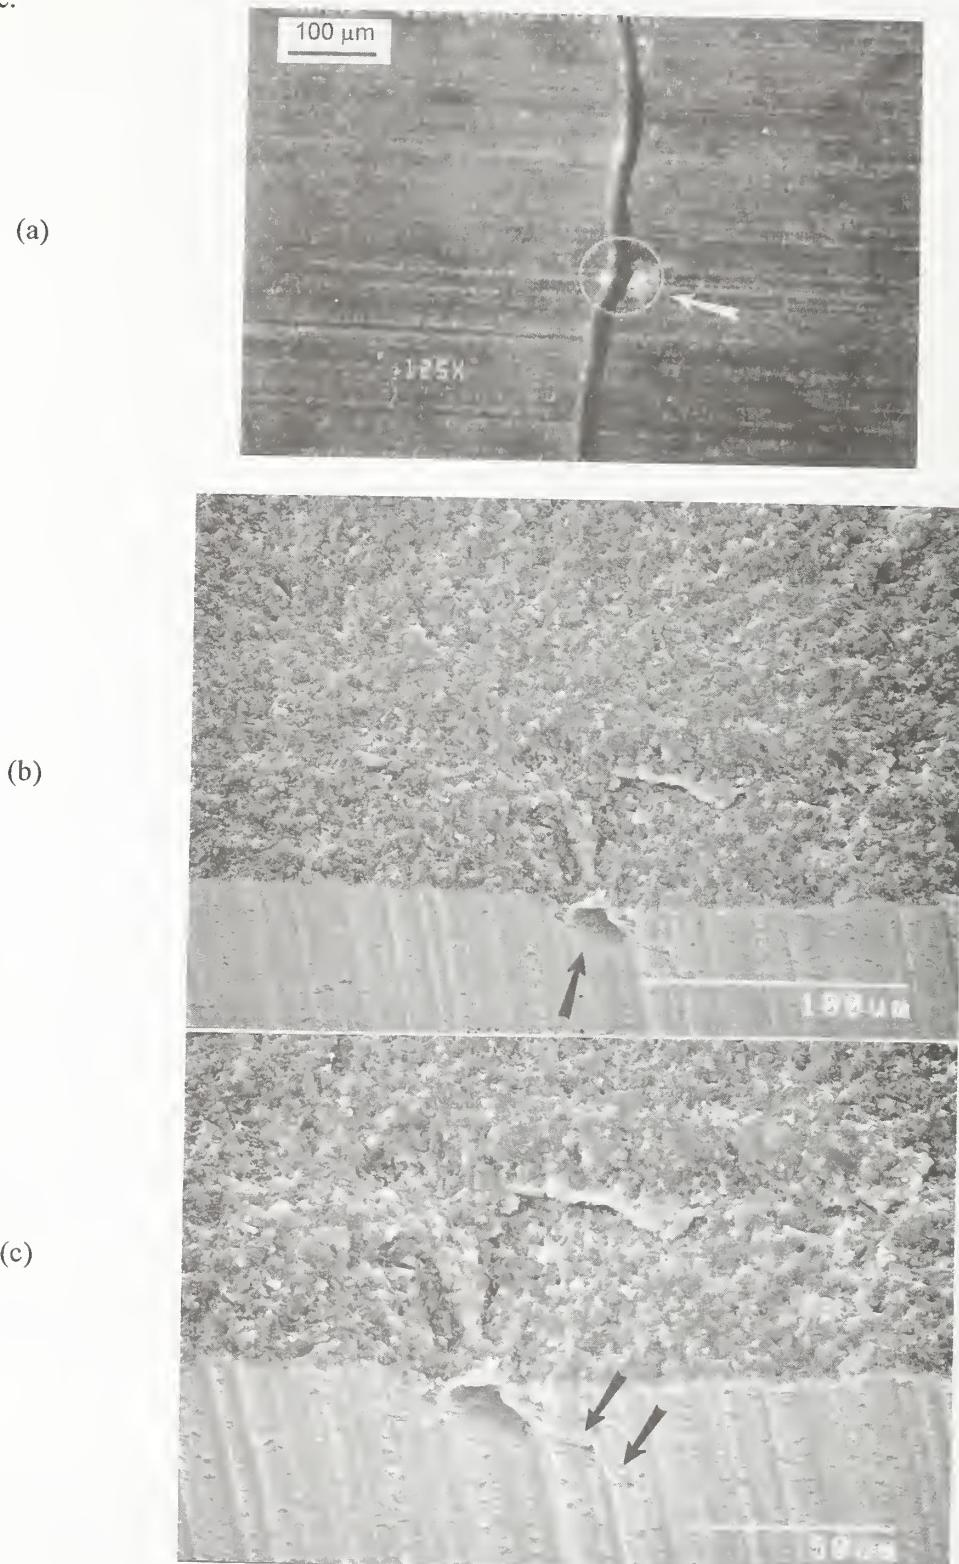
**Figure 29** Agglomerate/pore type flaw detected in a 320 grit longitudinally ground Shop C bar. These flaws were almost always located at or near the surface of the bars and may have been altered or enlarged by orthogonal crack machining damage (535 MPa).
